Debris/Ice/TPS Assessment And Photographic Analysis For Shuttle Mission STS-36

April 1990

DEBRIS/ICE/TPS ASSESSMENT
AND
PHOTOGRAPHIC ANALYSIS
OF
SHUTTLE MISSION STS-36

February 28, 1990

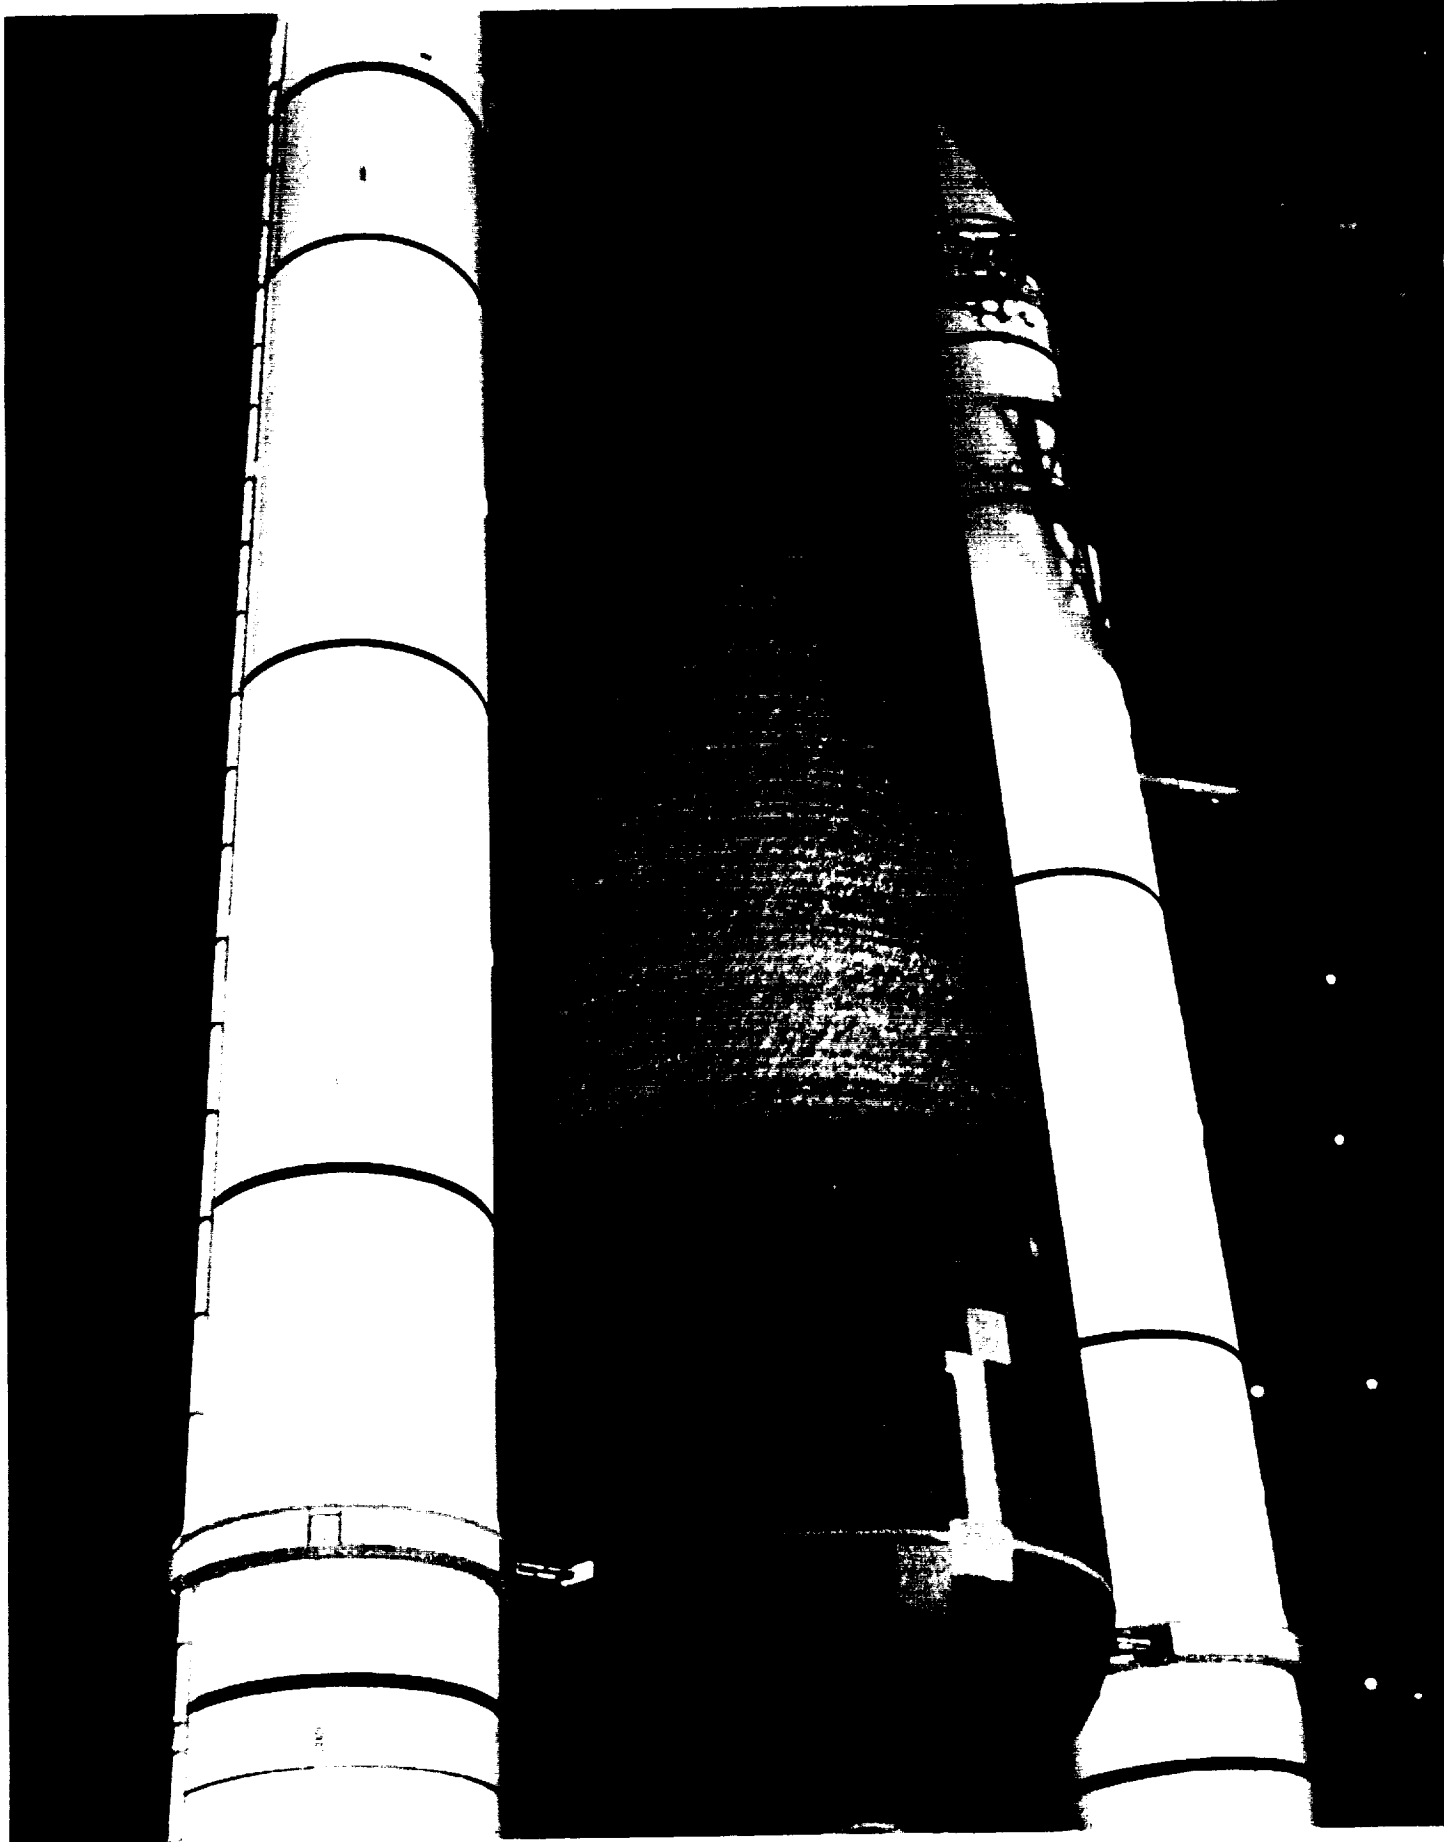
Frost accumulation on the LH2 tank acreage -Z side at the time
of the Ice Team inspection at T-3 hours

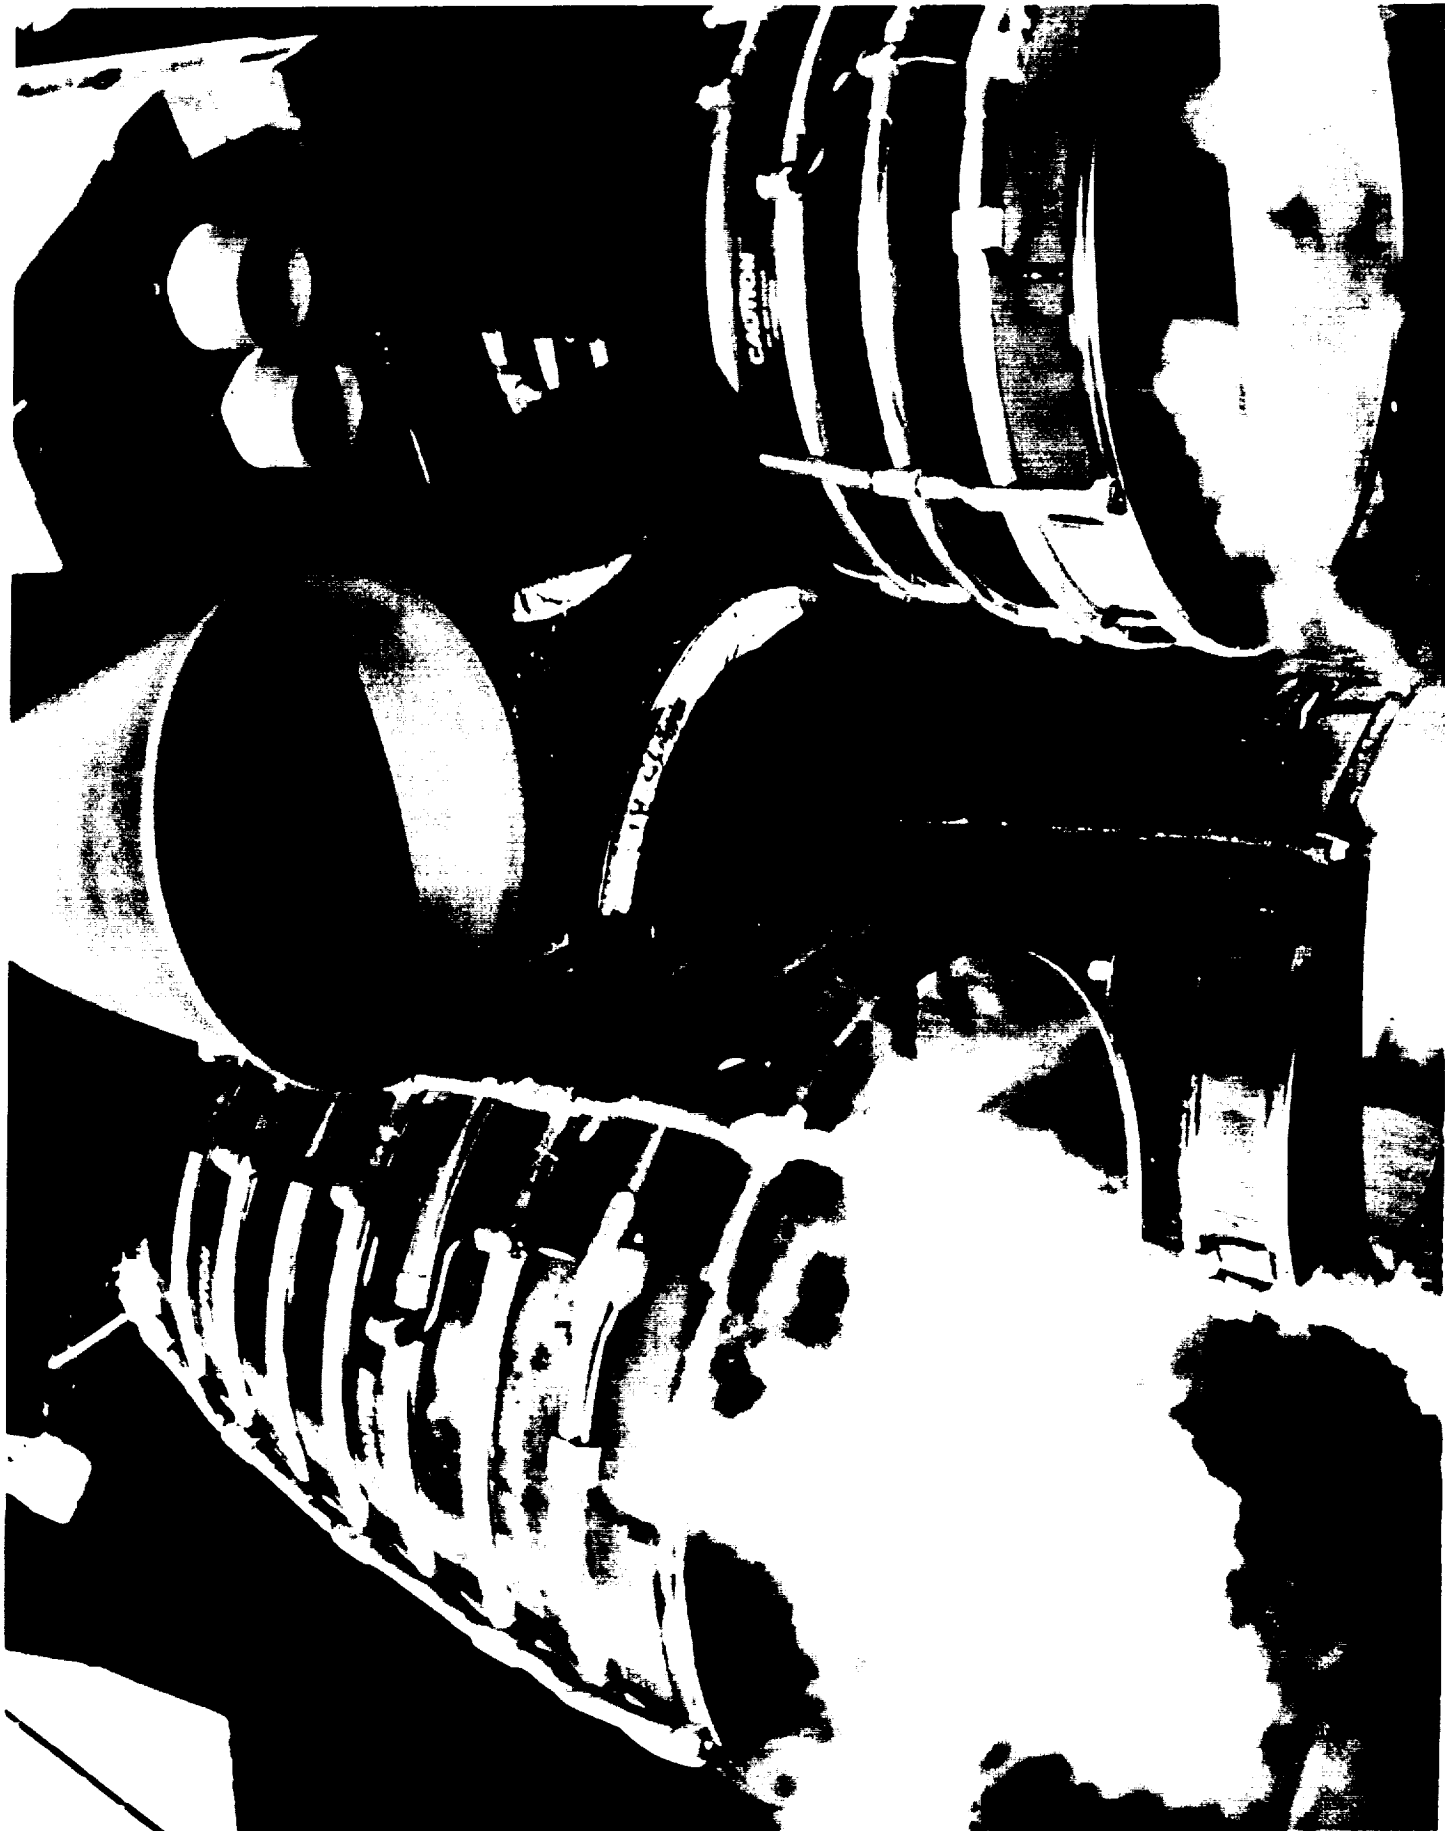
Overall view of the Main Engines shows ice/frost formation
on the SSME #2 engine heat shield-to-nozzle interface

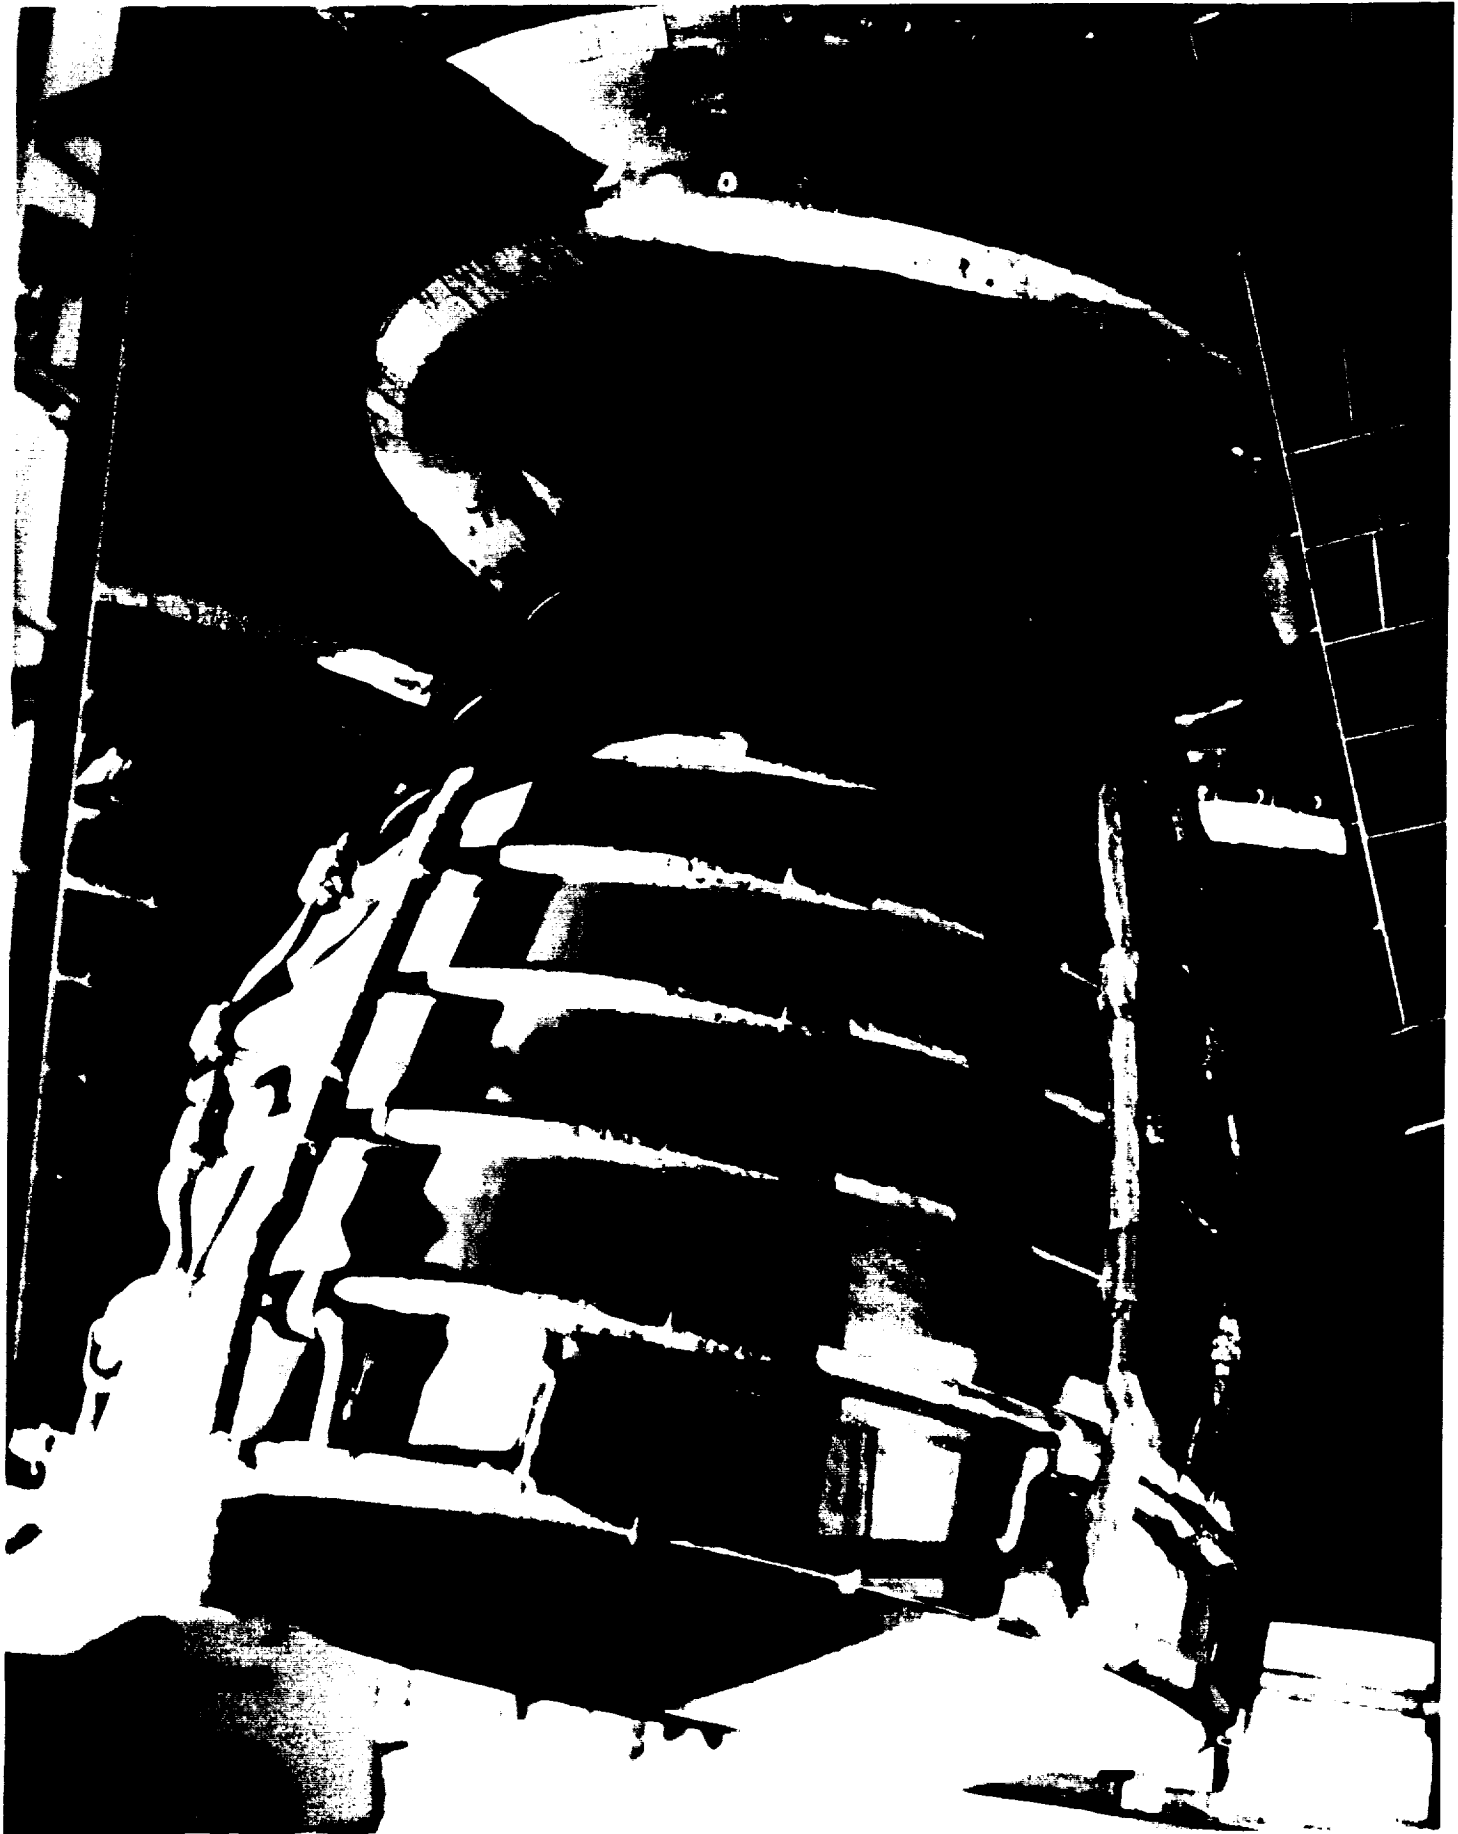
Ice/frost has formed along the SSME #1 and #2 engine mounted
heat shield-to-nozzle interfaces

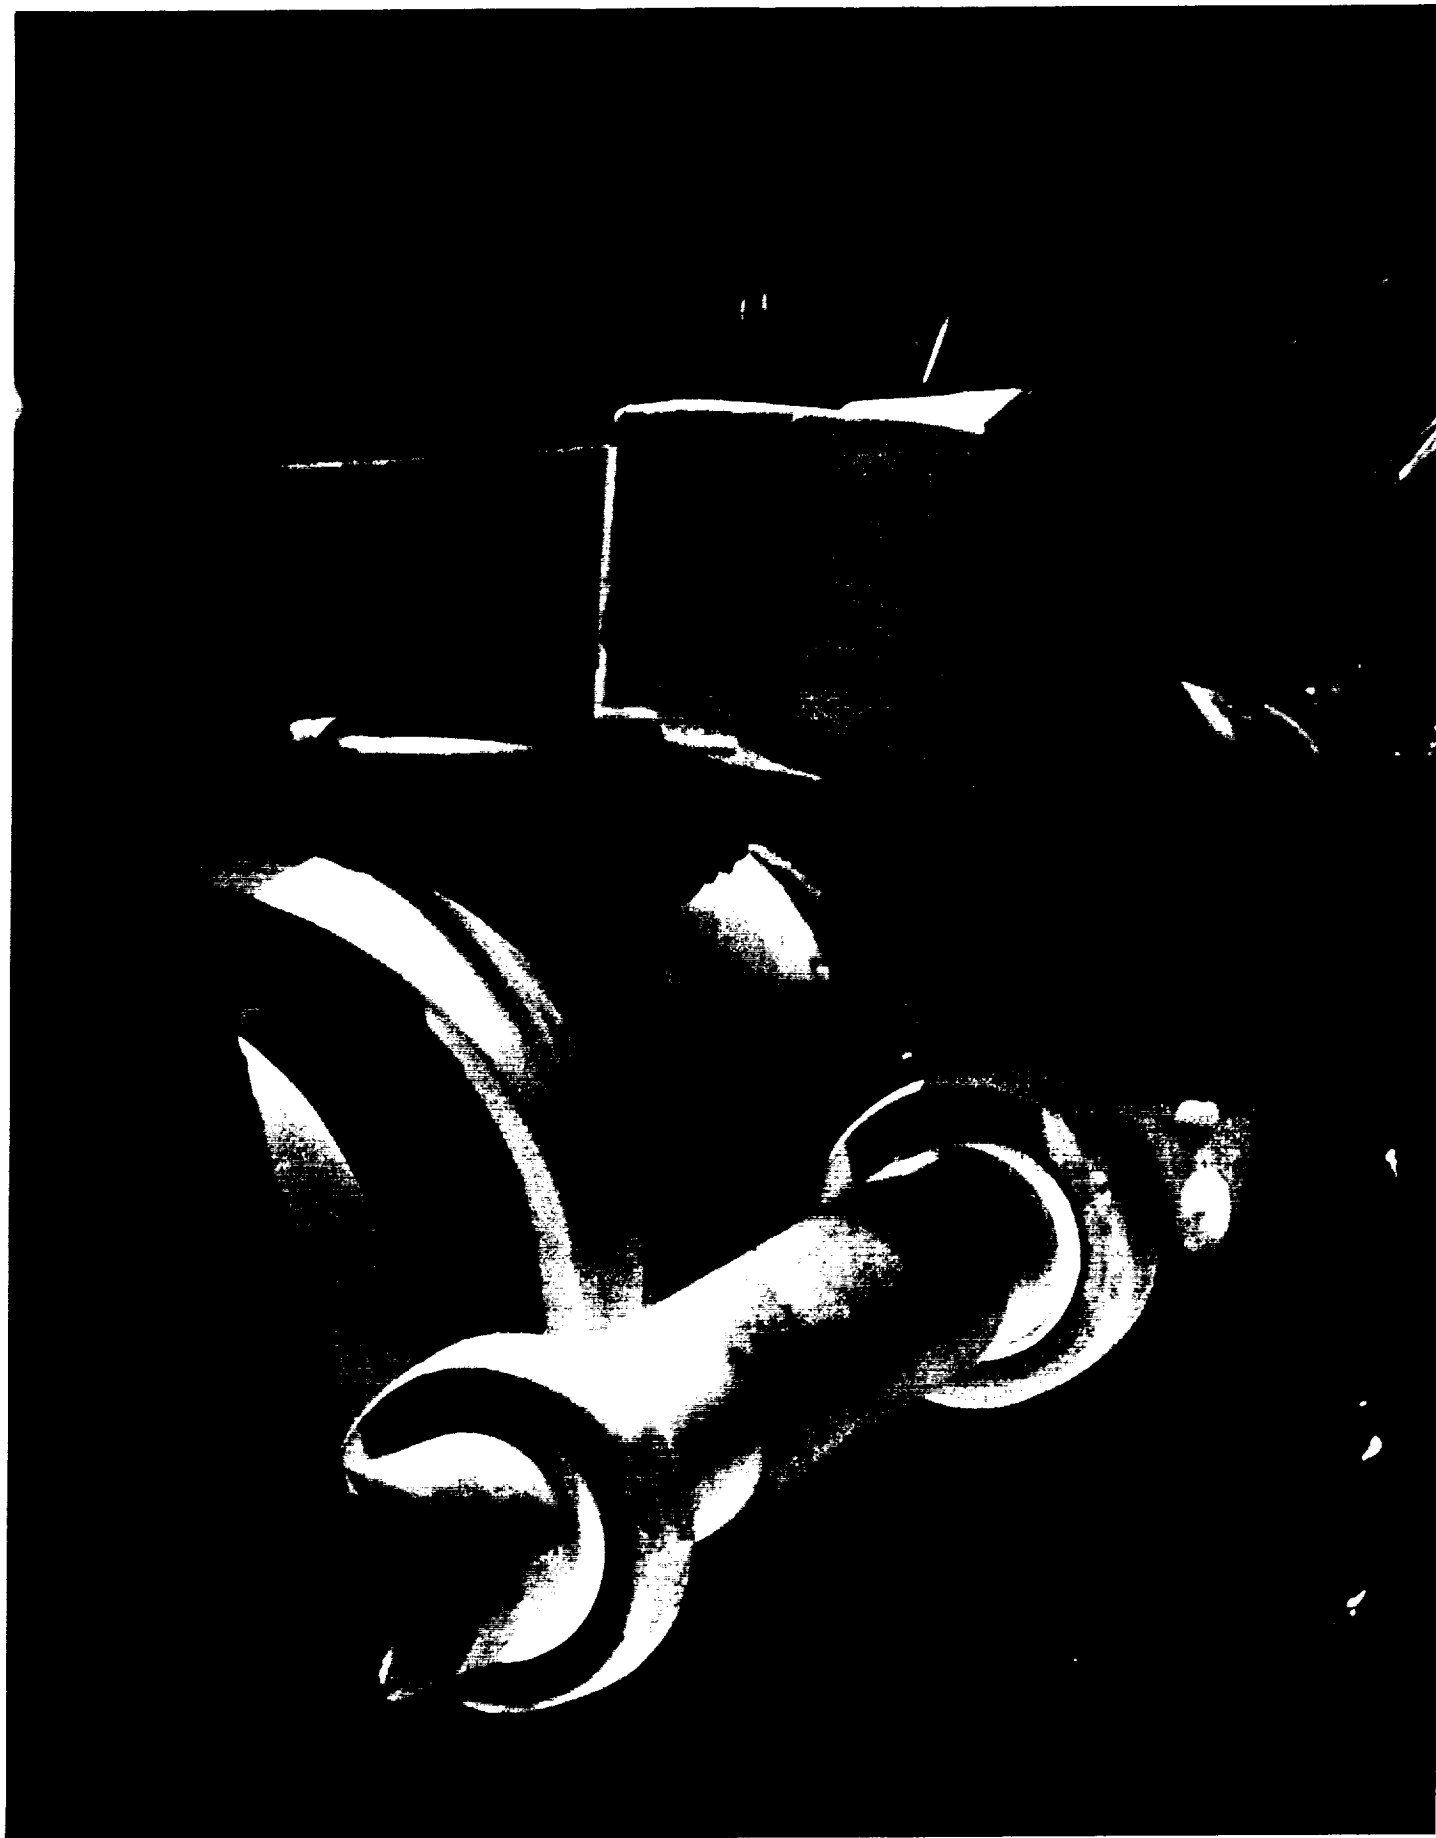
LH2 feedline bellows remain clear of ice/frost, though light accumulations are present in the LH2 recirculation line bellows

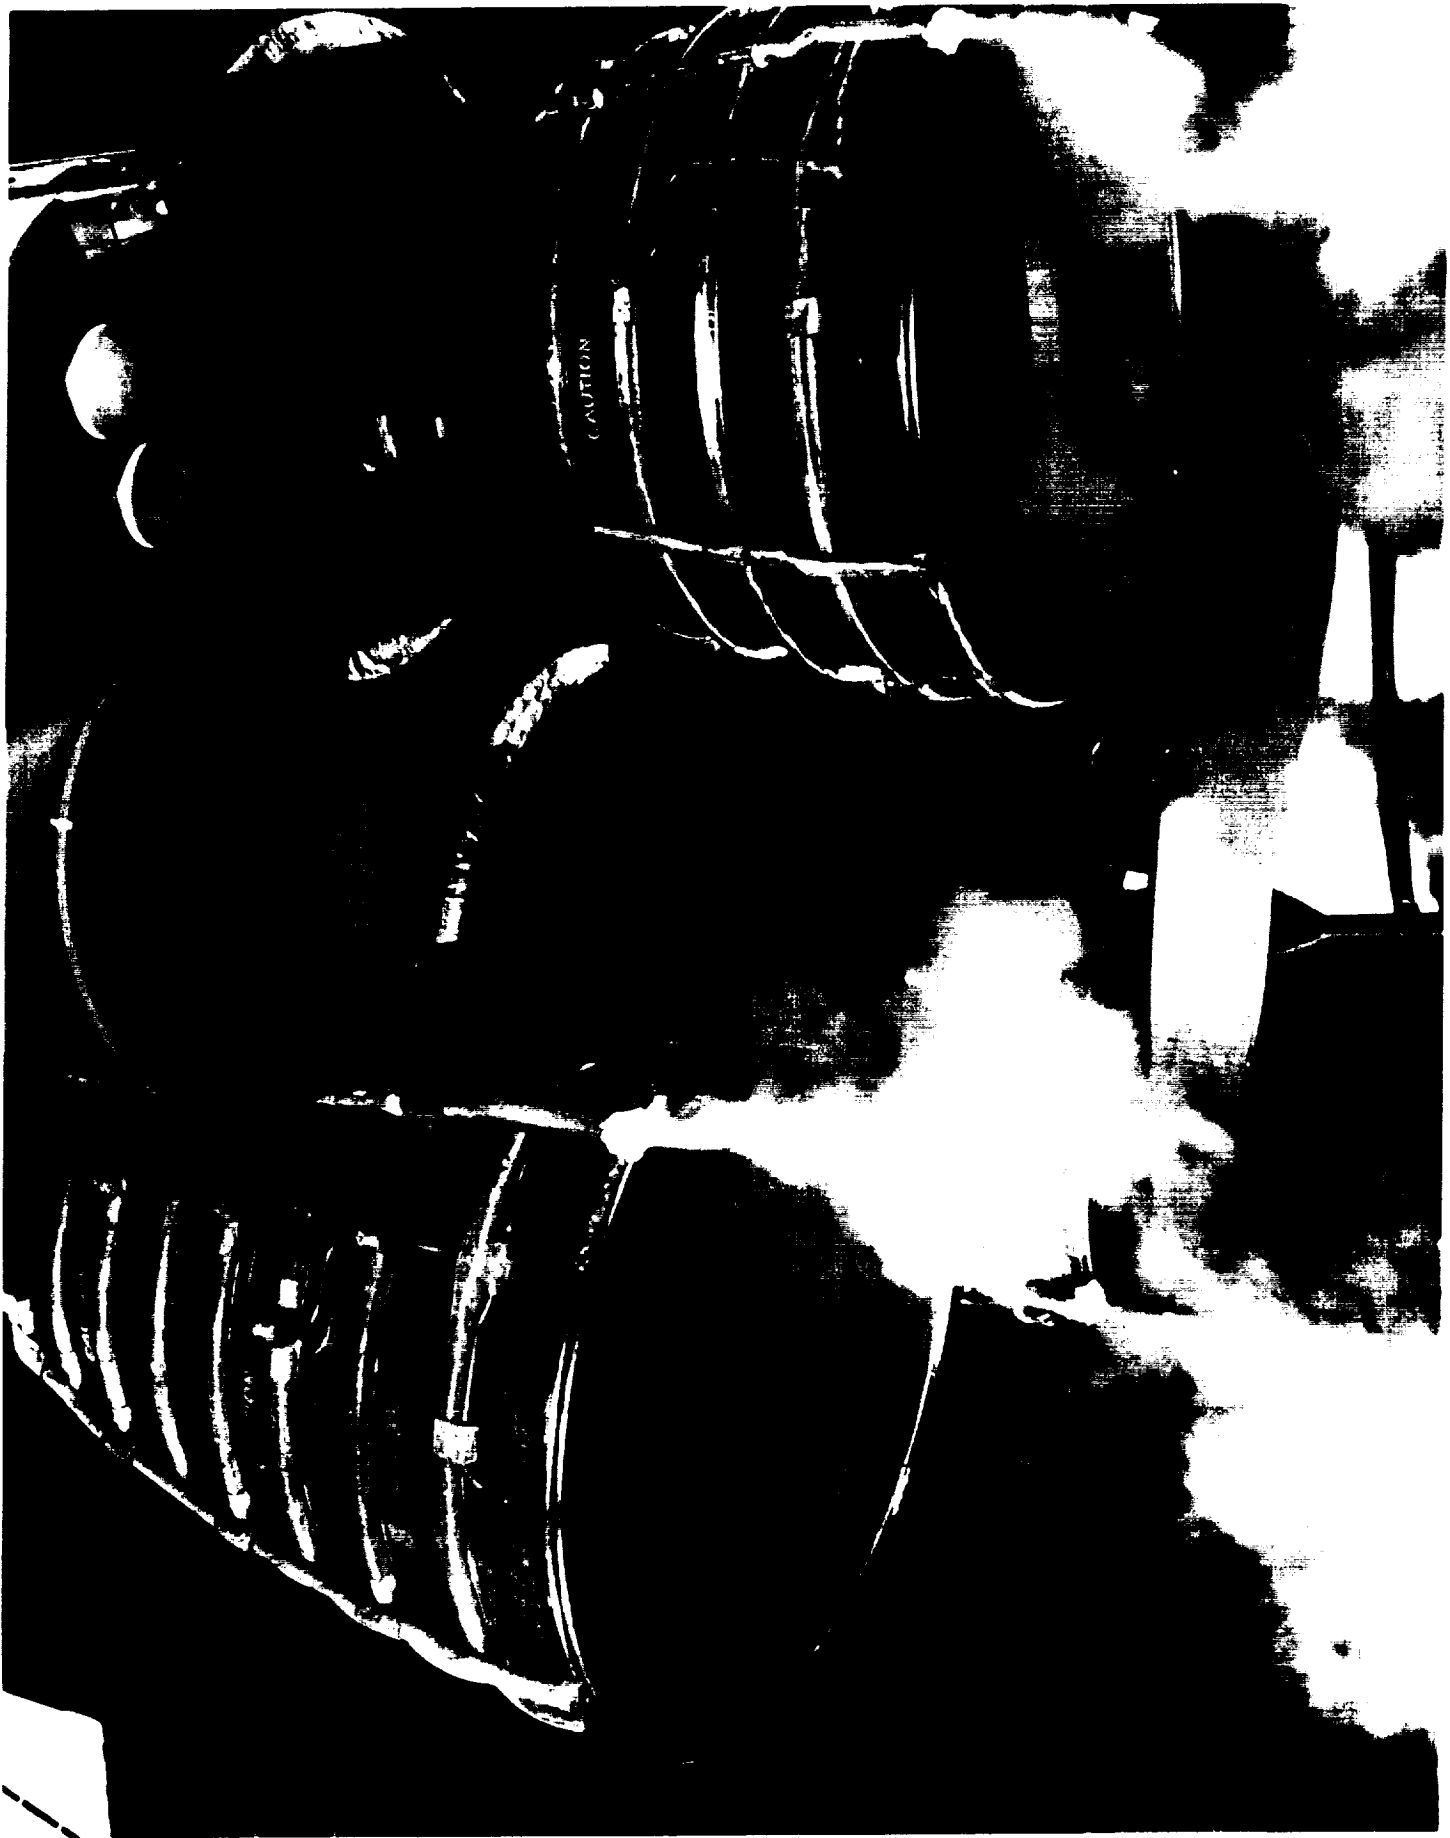
Overall view of Shuttle Main Engines shows frost along the
SSME #2 engine heat shield-to-nozzle interface

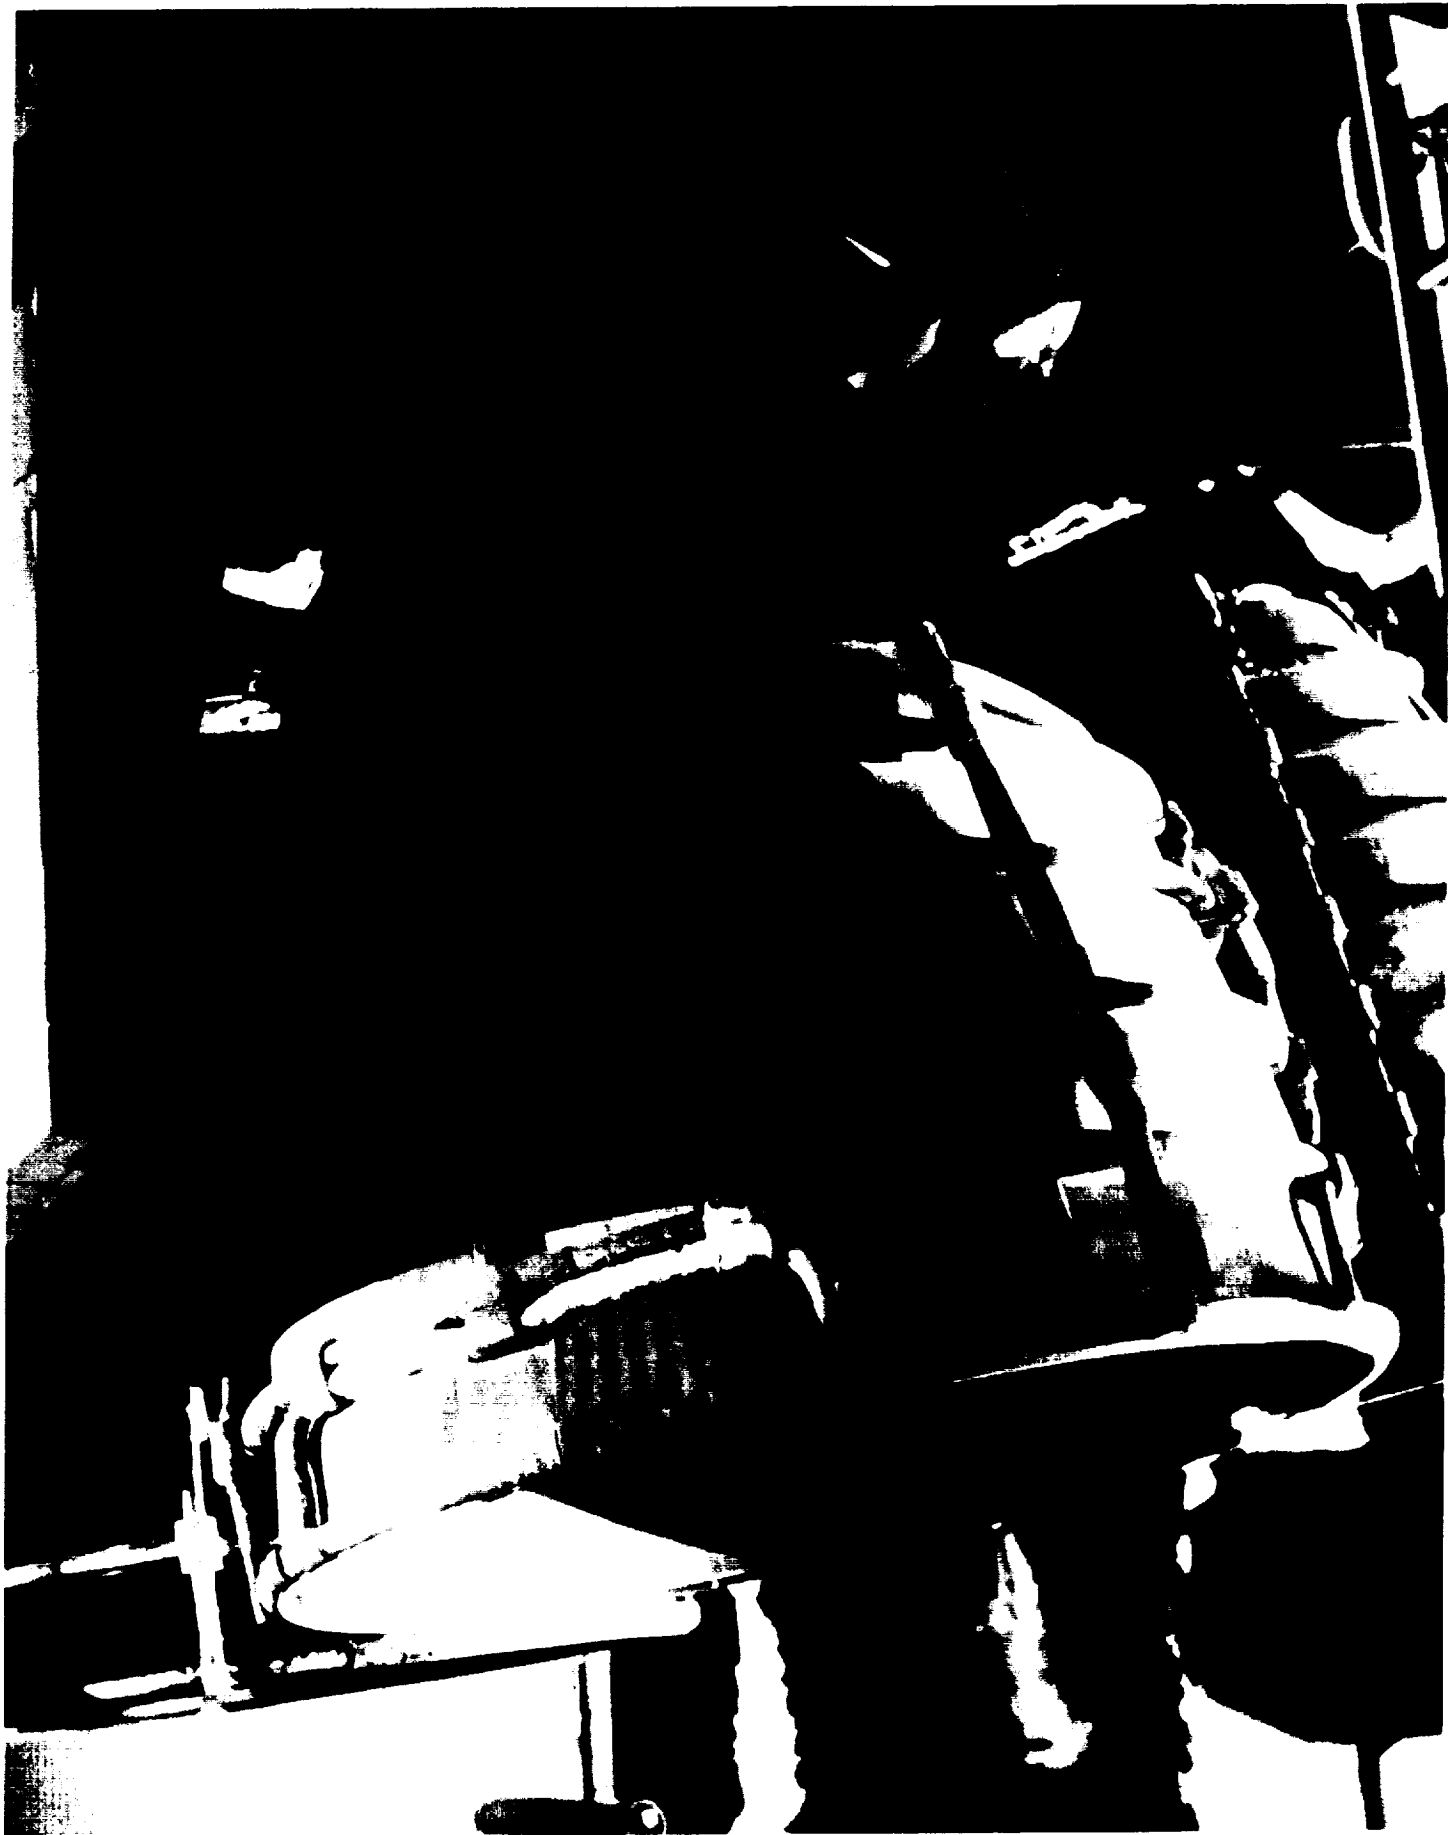
Ice/frost has formed along the SSME #1 and #2 engine mounted
heat shields-to-nozzle interfaces

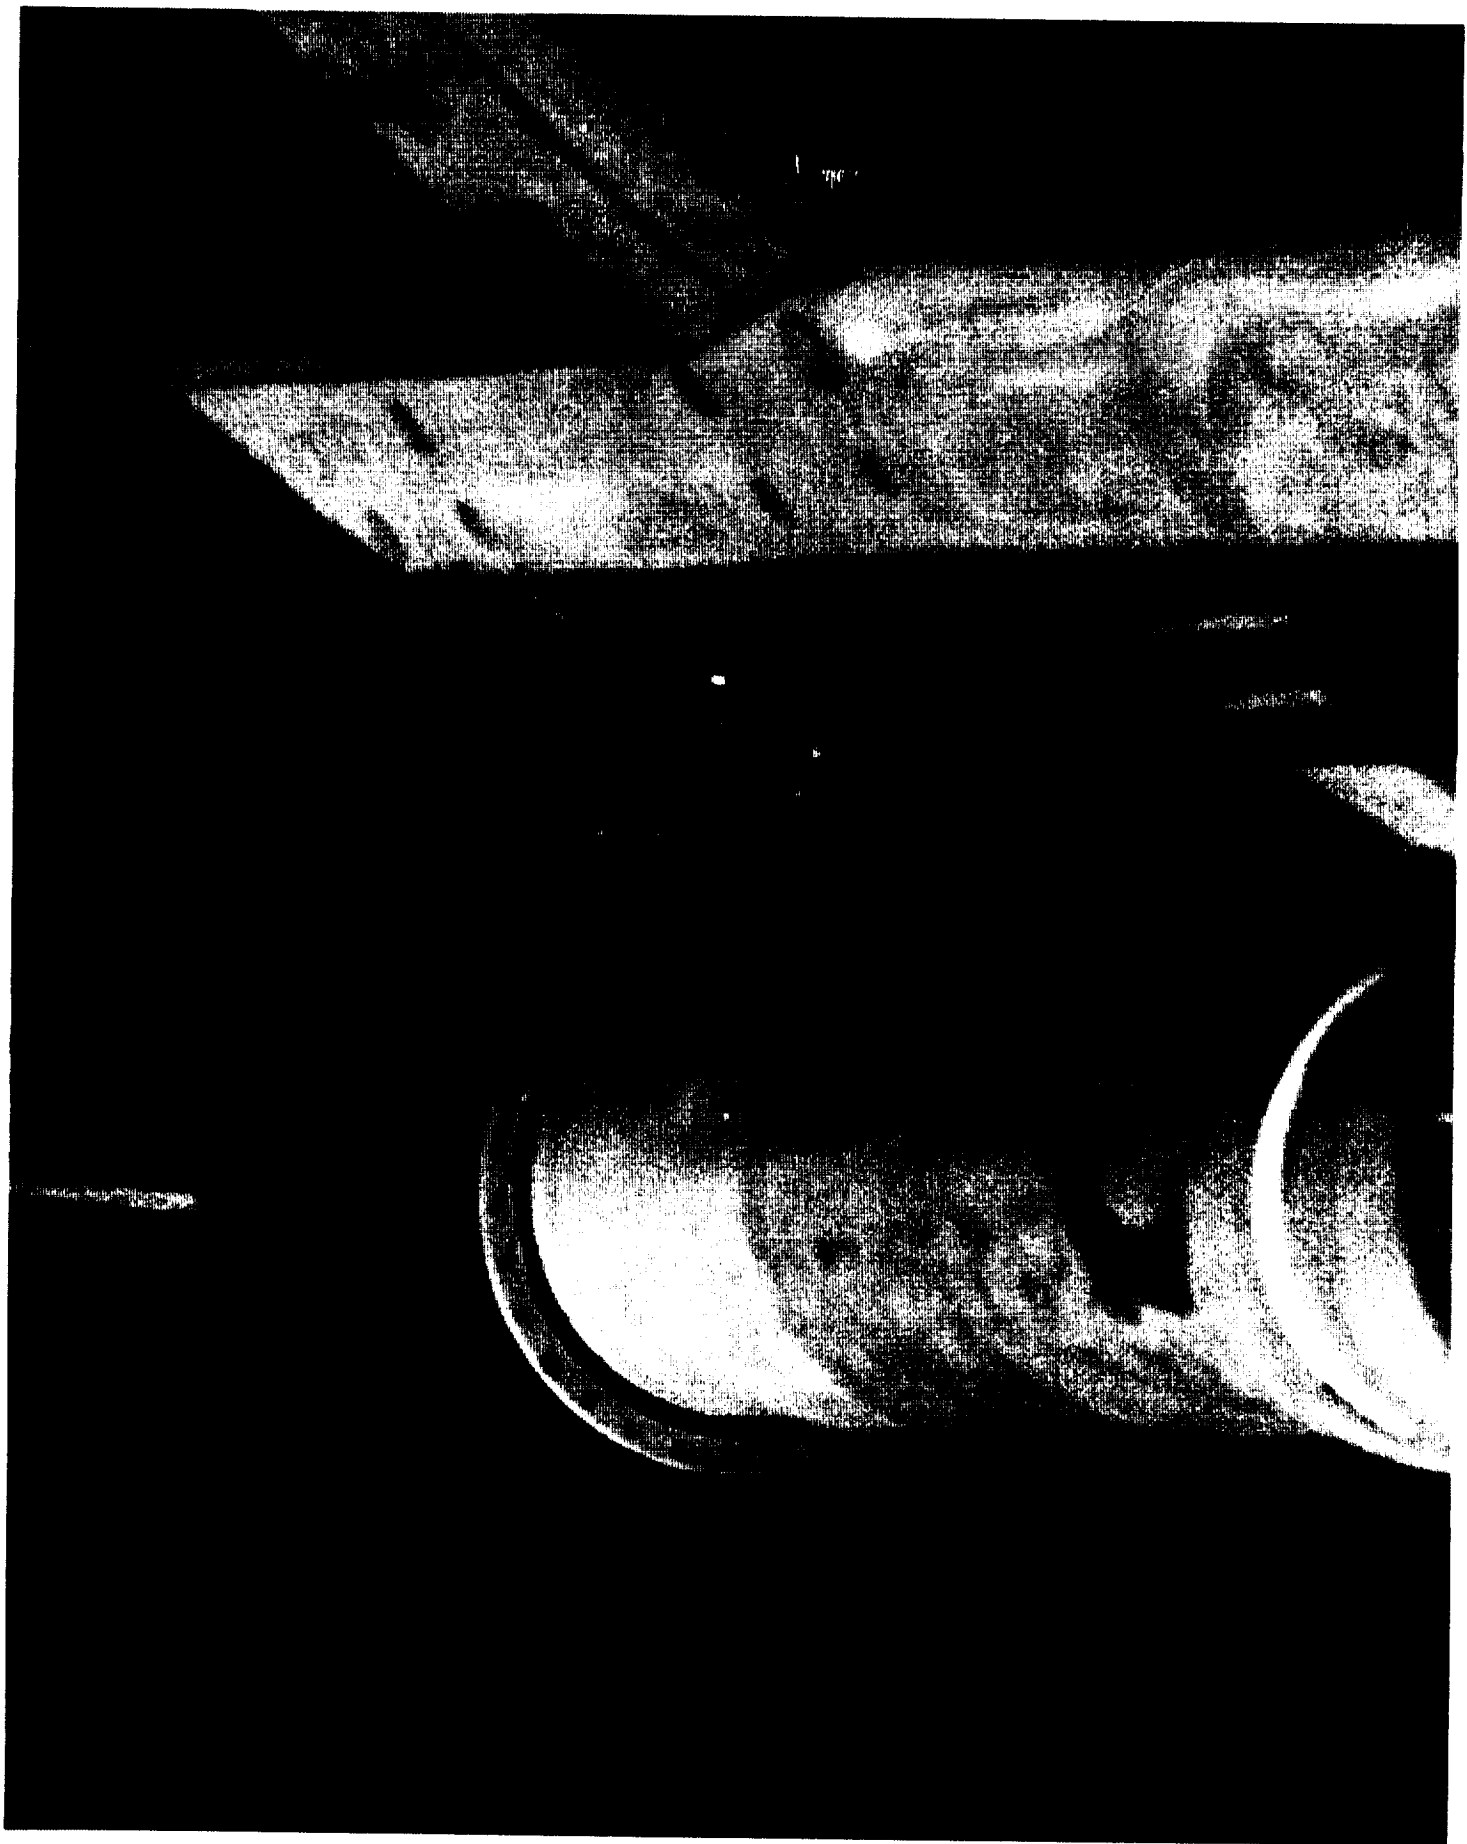
A typical accumulation of ice/frost was present in the
LO2 feedline upper bellows

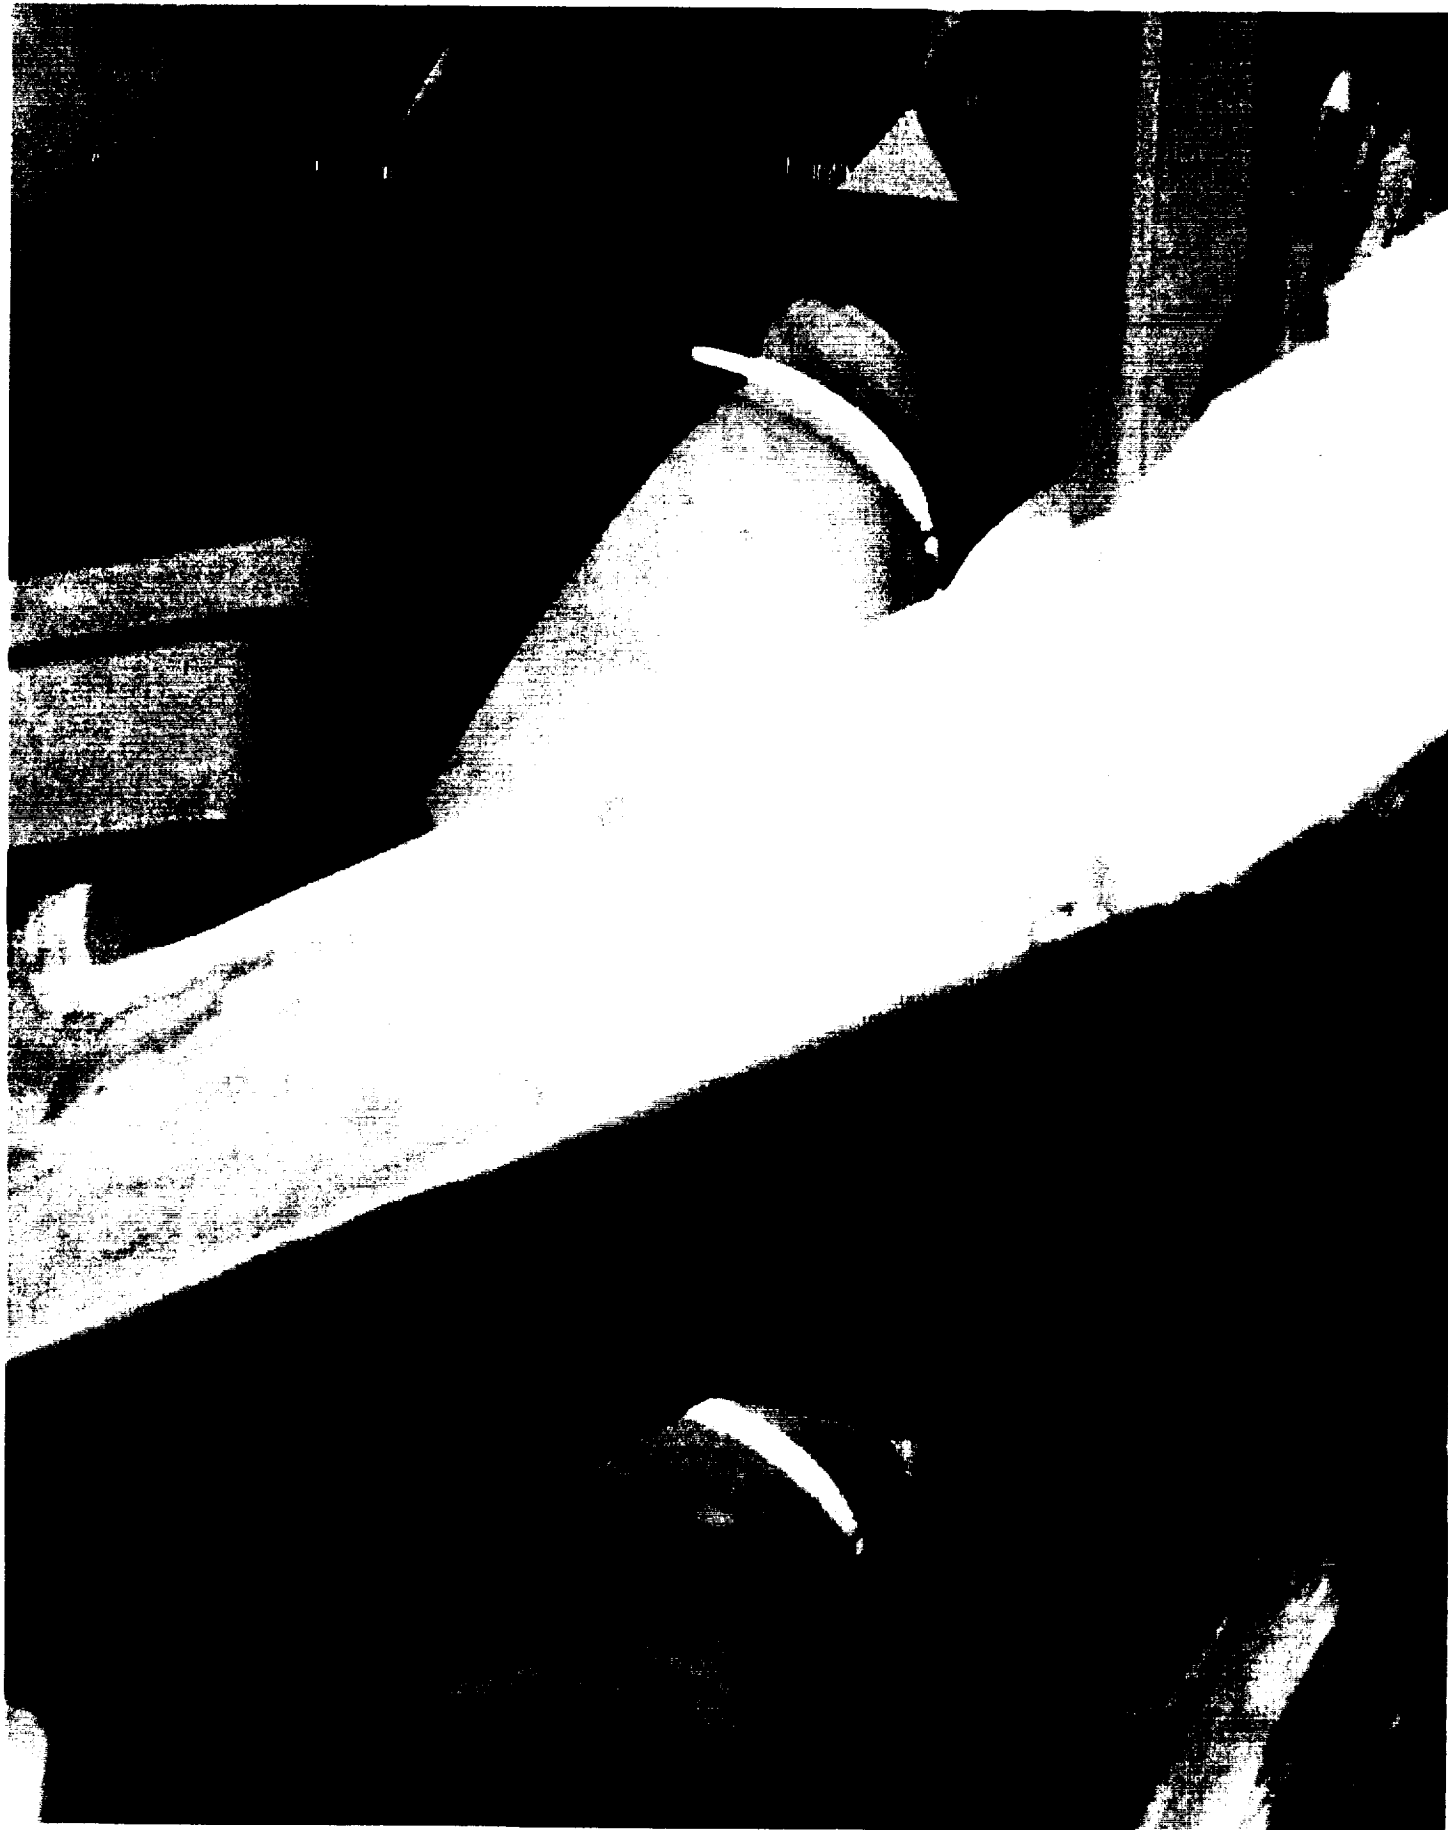
A typical accumulation of ice/frost was present in the
LO2 feedline lower bellows
